# Analysis of Brittle Fracture of Composite Insulators by using Finite Element Technique

**Abstract:** The Brittle fracture process causes cracks on the FRP rod of the Composite (Composite) insulator that leads to premature failure of Composite insulators. Major types of stress affecting the service life of an insulator are electrical, mechanical and environmental stress whereas the major physical threat is vandalism. For various transmission and sub-transmission voltages, the insulators are required withstand the maximum tensile strength of the conductor. Therefore, understanding the mechanical stress withstanding capability of Composite insulator is important. Proper designing of the strength of FRP (Fibre Reinforced Plastic) rod is most important. FEA (Finite Element Analysis) analysis of voltage distribution along the length of the Composite insulator is also necessary for the understanding of electric field stress required for surface deterioration of Composite insulator. The mechanical stress analysis for various cross sections of FRP rods for a given mechanical load has to be carried out in order to optimize the diameter of the FRP rod for better reliability. FRP rods of di

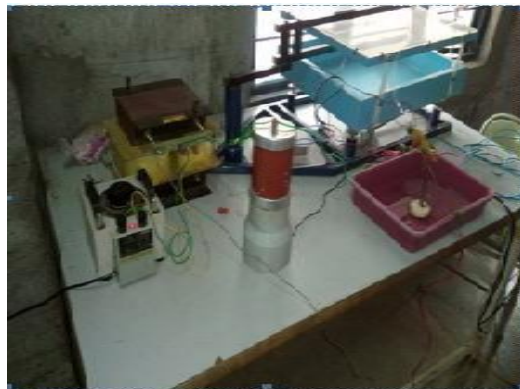
Two samples (A and B) of FRP rods of 15 mm diameter and 150 mm length were subjected for Erosion, tracking and brittle fracture tests. They were placed in stand used for inclined plane tests and copper foils were used as electrodes with 4cm distance between electrodes. A nozzle was fixed over the rod for proper drip of nitric acid solution. Drops were directed to drip at line end of electrode along the FRP rods. Variable voltage is applied to the specimens from an AC source 230V/5kV transformer. The voltage was applied to one of the electrodes and the other was earthed. The duration of the test was about 60 minutes. The drip rate of the solution was also varied from 10 drops/minute to 30drops/ minute. Scintillations were observed between the electrodes connected to FRP rod, which is as shown in Figure 3.

Figure 2: Experimental setup for FRP Rod test

The Schematic of the experimental test set-up to study erosion and tracking of FRP rod is as shown in figure 1. Experimental setup for conducting these tests in the laboratory is as shown in figure 2. Severity used for the brittle fracture experiment is of 0.1N and 0.5N of HNO<sub>3</sub> solutions. Periodic observations were made and samples were assessed. Samples of FRP rod used in Composite insulators were considered and the tests were carried out on the sections of FRP rods, without polymer shed.

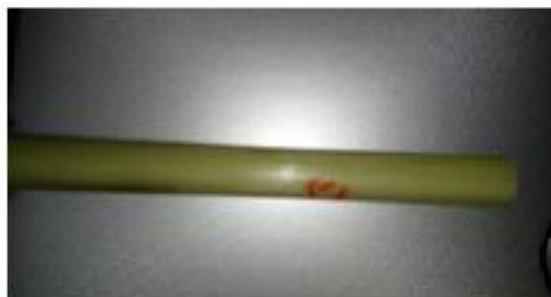
Experiments were carried out in order to understand brittle fracture of FRP rod. Sample of FRP rod before placing it for test is as shown in Figure 4.

Figure 4: Sample of FRP rod

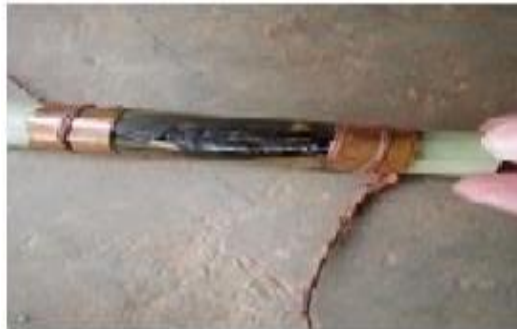
Test results of Sample A: Though the tracking and erosion was observed in sample A, they were of lesser severity compared to Sample B. Tracking and erosion of samples A and B are as shown in figures 5 and 6 respectively.

Figure 5: Sample A of FRP rod - after test

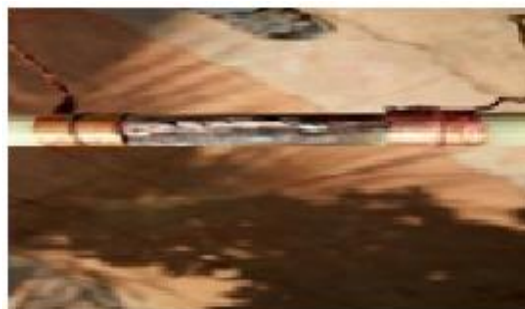
Test results of Sample B: It is observed that tracking and erosion was high in sample B.

Figure 6: Sample B of FRP rod - after the test

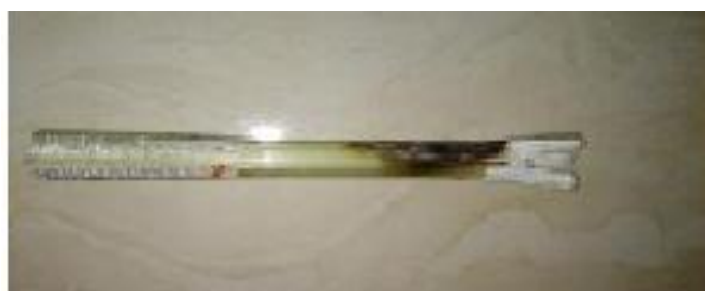
After tracking and erosion on samples A & B, mechanical load was applied on the samples in order to obtain brittle fracture in the laboratory. FRP rods were subjected to tensile strength test. The FRP rod of Sample-A got fractured at peak load of 68kN. The photograph of brittle fracture is as shown in Figure 7. Sample B was also subjected to Mechanical load test, and it fractured at about 60 kN as shown in Figure 8 showing that the sample B is inferior to Sample A. It can be seen from the results that the sample A, is of good quality. The Fractured sample (Sample B) shows similar pattern of the failure in the field.

Figure 7: Brittle fracture of FRP rod Sample A

Both the rods were subjected to tensile load & they failed at 68kN (Sample A) & 60 kN (Sample B) respectively. On the observation of failures in both samples of A & B, it can be seen that, the brittle fracture occurred at the eroded zones. After the tensile load it can be seen that sample A is better than Sample B, because of the reason that there are no fibres at the fractured areas.

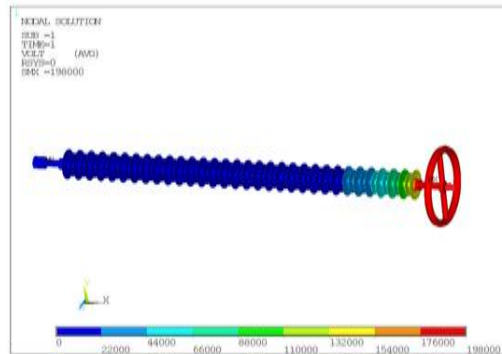
The voltage distribution pattern is as shown in Figure 11 and it is observed that maximum voltage is at the line end with 198 kV and keeps decreasing from line end towards ground end.

Figure 11: Voltage distribution along the insulator

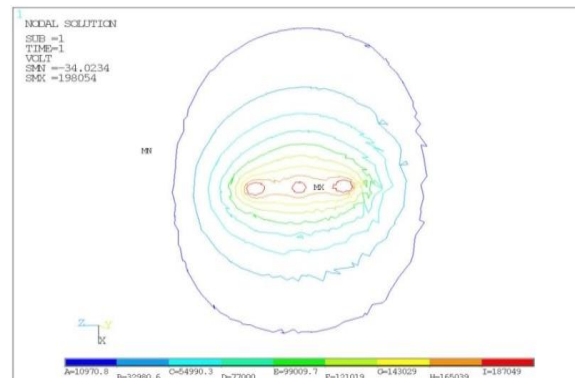
The voltage distribution and maximum is observed at the line end with 198000 V. Corresponding electrical potential distribution lines are shown in figure 12.

Figure 12: Electrical potential distribution lines

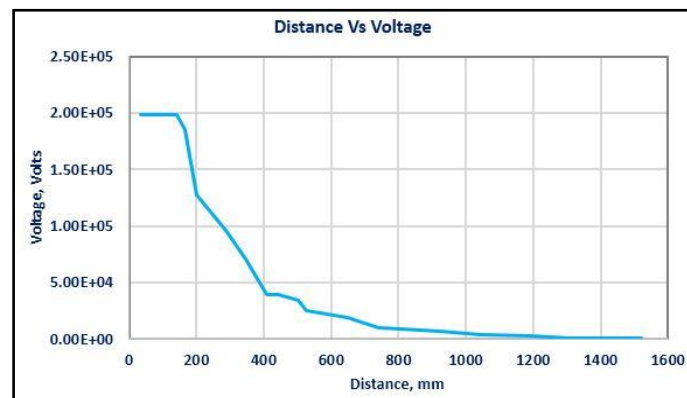
The voltage values at different distance from line end to ground end is shown in table 3.1 and plot of graph of variation of voltage with respect to distance is as shown in figure 13.

From the graph, it is observed that most of the voltage drops across the length of the insulator from 170mm to 400mm from the line end, i.e. the drop in the voltage is about 150kV. The average stress in this region is  $150\text{kV}/23\text{cm} = 6.52\text{kV/cm}$ . The intensity of the stress is high at the line end and decreases sharply to 1/4th of the insulator length.

Figure 13: Distance V/s Voltage distribution – Case 1
